## Inefficiencies and solutions for the conveyor return

Dan Marshall Dan/Process Engineer, Martin Engineering

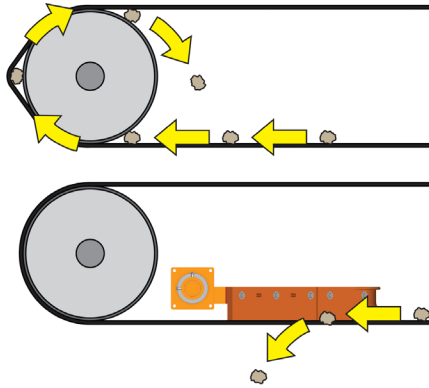
1 A V-Plow helps prevent repeated entrapment of material between the belt and tail pulley

putting a new divot in the belt, as well as gouging and fouling the pulley face. This material can become ground into fine dust or ejected from the pulley. Plows are often used to clean the inside of the belt and protect the tail pulley and belt from damage [Figure 1].

Tail pulley protection from build-up riding on the return side of the belt using a V-Plow or diagonal plow can extend the life of the entire system by minimizing fouling of the pulley face that can lead to mistracking. Attached with dual steel crossbars bolted to the conveyor frame ahead of the tail pulley, the units employ a unique torsion arm suspension system, which adjusts to fluctuations in belt tension to maintain consistent pressure for effective cleaning in all stages of wear. Lightly riding on the belt, the diagonal design deflects debris away in a specific direction, while the V-plow design deflects debris to either side. Where large lumps or broken idlers are getting on the return side of the belt, a tail protection plow designed for high impact is used, often in addition to or in combination with a return belt cleaning plow.

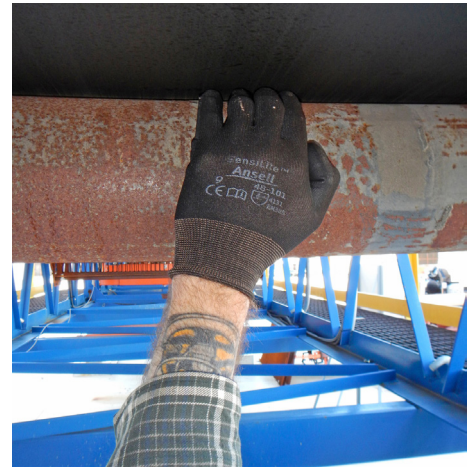
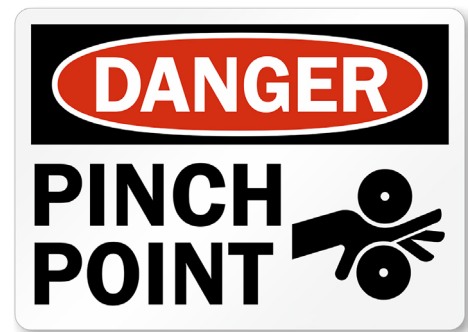
2 Proper signage should be displayed wherever a hazard presents itself

According to OSHA [3], operators should adhere to the standards set by the American National Standards Institute (ANSI), which recommends detailed inspections of the entire conveyor mechanism [4]. The first step is identifying potential problems before they occur [Figure 2]. The second step should be putting an emphasis on training and enforcing strict lockout-tagout procedures for any activities on or around the conveyor system.

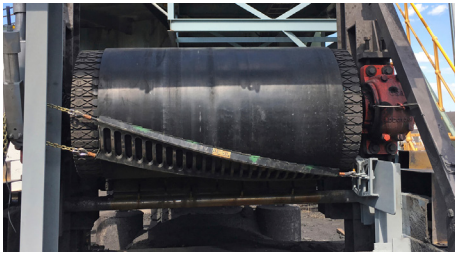
3 Innovative belt cleaning technology can improve cleaning, safety, and the cost of operation

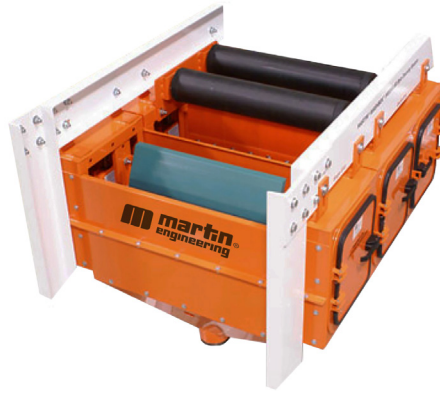
5 Thoroughly clean a damaged belt with a washbox

In such cases, operations may choose to install a Washbox Cleaning System, which combines secondary cleaners with water spray bars enclosed in a self-contained unit that captures residue and drains wastewater safely away from the work area [Figure 5].

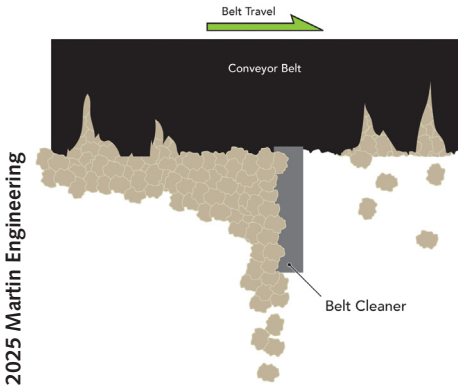
4 Cleaning a damaged belt with a scraper blade

In most applications, normal belt wear can yield valleys and depressions in the belt. Dust and fines that get into these blemishes often remain even after passing under primary and secondary belt cleaning blades, becoming dislodged by the impact of any return idler the belt meets [Figure 4]. This causes dust and spillage in areas away from the head pulley.

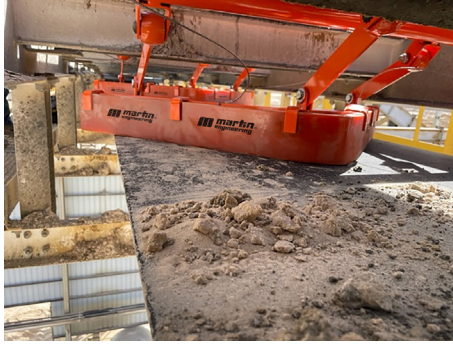
6 The workhorse of tail pulley protection, the V-plow safely clears debris without harming the belt

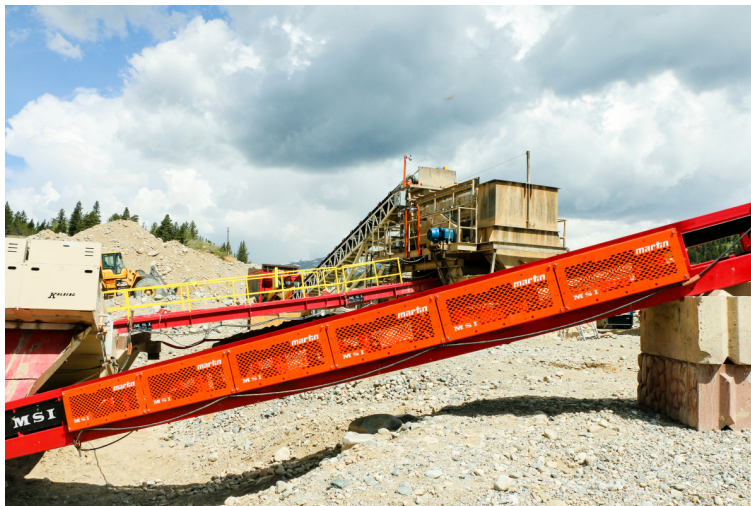
7 Conveyor guarding prevents reach-in, but also constrains fugitive debris to under the system

Installing adequate guarding that encloses the system and has the correct mesh size and mounting distance from the hazard also helps protect workers from fugitive material and reach-in injuries. For systems that are considered “guarded by location” (too high to reach), gates may not be required, although most countries have standards that require guarding against falling bulk materials [5].

Return roller guards -- though seldom seen except over roads and walkways -- improve safety and meet the growing demands of government regulations. Build-up under the conveyor or on work platforms can negate the guarded by location “too high to reach” criteria, so best practice is to guard all known hazards or eliminate the hazard by design.
